Building Inspection Report

123 Dream Home Lane, Anytown, NC 27000

December 31, 2010

123110-01

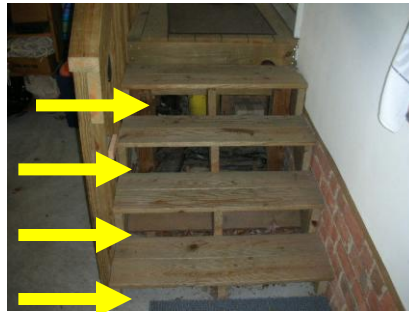
no risers between the garage and rear deck stairs. The opening is 6 or more inches and is a safety hazard. Repair by a licensed general contractor.

Oversized opening in garage stair

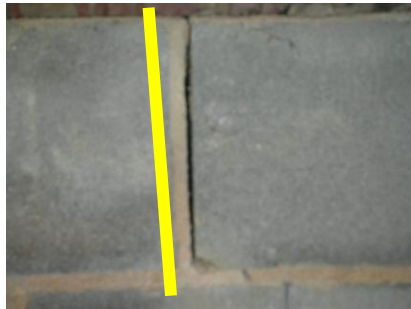
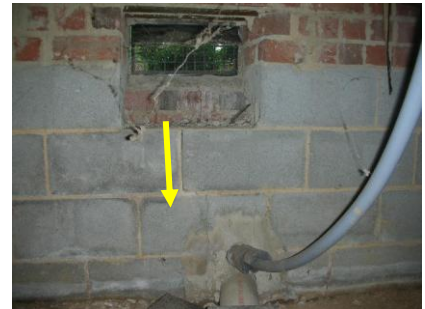
Further Investigate: There is a crack in the front foundation wall under the living room window. The crack extends through the concrete block and matches the crack in the exposed brick veneer. The foundation is cracked. Further investigate by a foundation contractor or professional engineer with structural experience to determine the cause as well as design and implement a repair procedure.

Crack in front foundation wall under living room

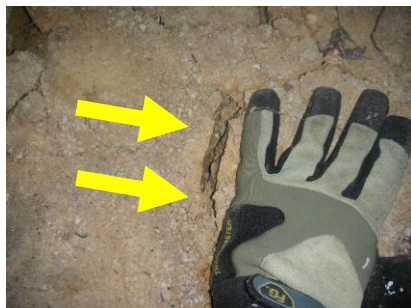
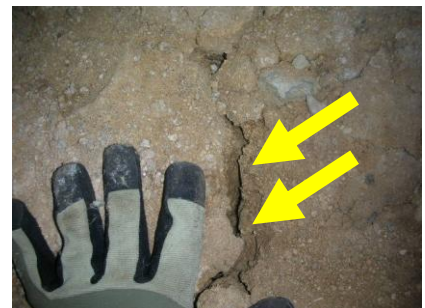
Further Investigate: The vapor barrier does not completely cover the crawlspace floor. In the exposed area at the front wall foundation, the soil is dry and cracked. The cracks are 1/2 to 1 inch wide and several inches deep. The soil around the foundation has dried and shrunk. This shrinkage may be the cause of the foundation shifting and cracking under the living room window. Further investigate to determine if the soil is the cause of the foundation cracking as well as design and implement a repair procedure.

Finger width cracks in crawlspace soil under exterior living room foundation wall

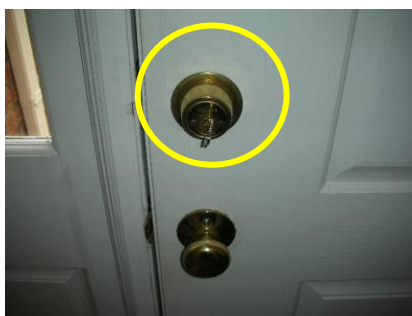
Safety Item: Commonly accepted building practices require all egress doors be readily openable from inside without the use of keys, special knowledge, or effort. The dead bolt lock on the front door is keyed from the inside. Occupants may become trapped inside during emergencies when the key is removed. Remove or replace the keyed deadbolt with a thumb latch style deadbolt by a locksmith.

Keyed deadbolt at front door

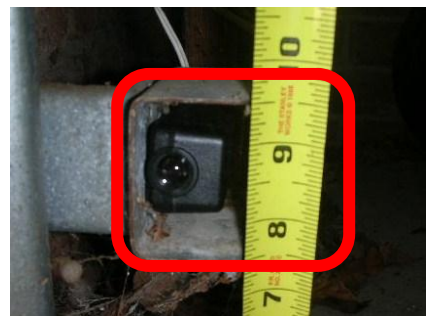
Garage motion sensor too high

Repair Item: The garage door motion sensors are present but are installed too high above the floor. Most manufacturers' installation instructions indicate the eye should be installed 3-8 inches above the floor. The motion sensor eyes are installed more than 8 inches above the floor. Repair.

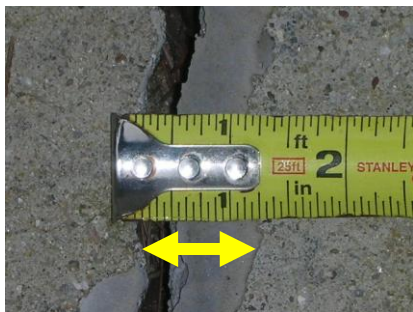
Repair Item: The driveway is cracked and moved horizontally 1 inch or more. The crack was repaired with a flexible sealant and the sealant has failed. The driveway is out of level and is a trip hazard. The driveway is no longer sloped to drain water away and instead has low spots with pooled water which serves to intensify the problem. Repair or replace the driveway.

Driveway crack with failed sealant

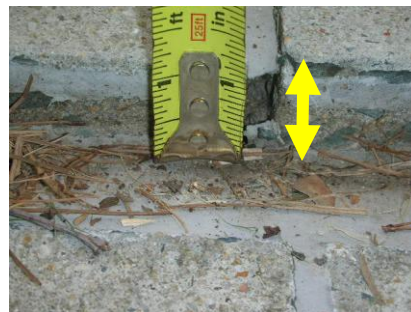
Driveway over an inch out of level

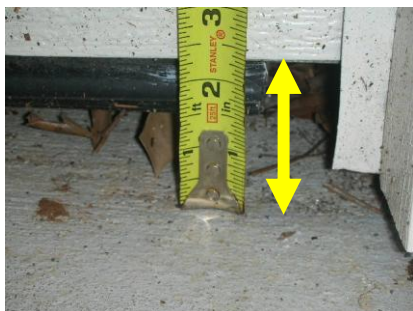
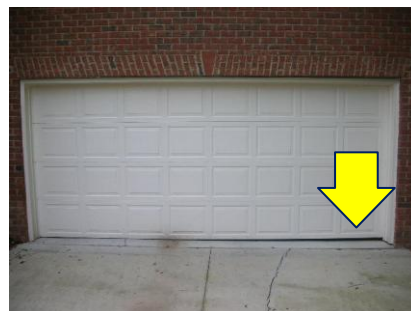
Further Investigate: The garage door does not touch the garage floor on the right side when viewed from the exterior. There is a gap of over 2 inches. This can allow water and vermin access to the garage. This is an indicator of possible settling of the foundation at this location. Further investigate to determine the cause as well as design and implement a repair procedure for the garage floor.

Gap at right side of garage door

Wide angle photo of garage door gap

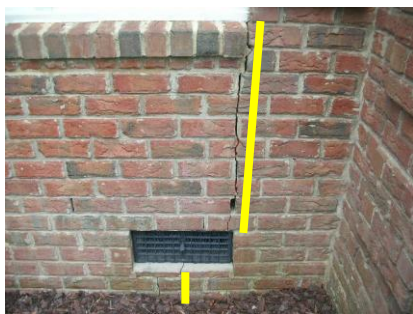
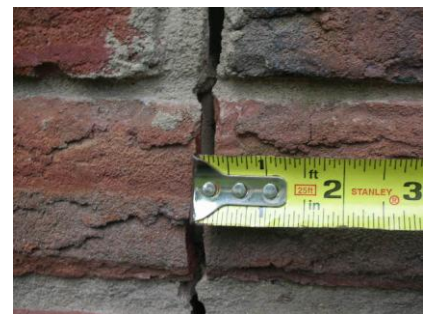
Further Investigate: There is a significant crack in the brick under the living room window. The crack extends from the soil up to the window sill and is about ¼ inch wide. The homeowner reports the crack appeared in the last 5-6 months since a mature river birch tree was removed within 20 feet of the home. Additionally several mature boxwood shrubs were removed that had been planted directly in front of the crack. The block foundation is visibly cracked at this location when viewed from the crawlspace. The plantings may have been maintaining a specific moisture content in the soil that has changed dramatically since their removal. The soil may have shrunk or swelled causing the foundation to shift forming the crack. Further investigate the crack by a foundation contractor or professional engineer with residential structural experience to determine the cause as well as design and implement a repair procedure.

Crack in brick under living room window

Close up photo of cracked brick

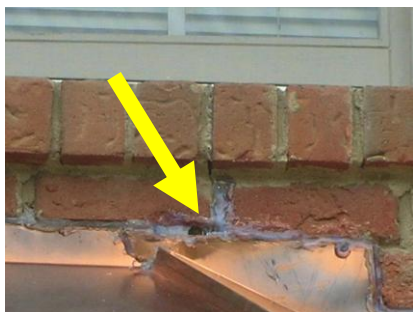
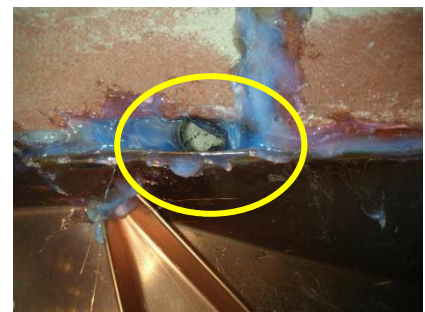
Repair Item: There is a gap between the copper roof over the dining room and the brick exterior. The hole is about the size of a dime and is at the upper edge of the copper roof where it meets the brick work. A bunch of caulk is applied around the seam between the roof and the brickwork. The hole is too large to be filled with caulk. The roof should ideally be let into the mortar joint to properly seal against moisture. Caulk is a temporary fix lasting 5-7 years. Copper roofs can last 75-150 years with proper maintenance. Remove the caulk and properly seal the roof to the building.

Dime sized hole over copper roof.

Close up photo of hole

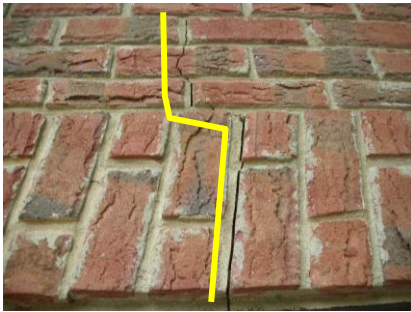
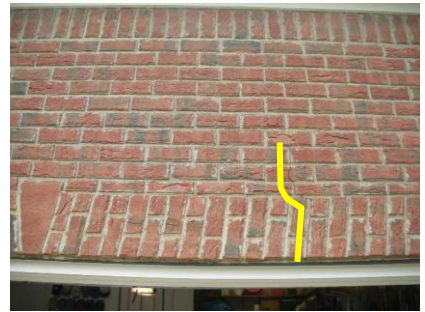
Further Investigate: There is a hairline crack in the brickwork over the garage door opening. The crack is about 4 feet right of center and extends from the metal lintel upwards about 2 feet. Subsequently observe to determine if the crack increase in length or width.

Hairline crack over garage door

Wide angle photo of crack over garage

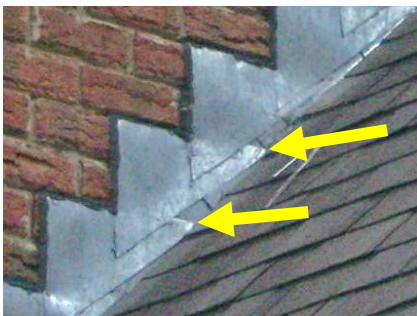
Further Investigate: There is flashing and counter flashing along the roofline between the garage and exterior wall of the main house. The counter flashing is cut incorrectly exposing the upper edges of the counter flashing and is not cut at the same angle as the slope of the roof. The counter flashing is installed very poorly and incorrectly. Repair or replace.

Upper edge of flashing exposed

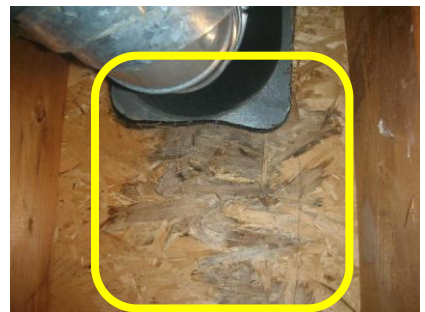
Water stains on roof sheathing

Repair Item: There is black water staining on the roof sheathing around the metal exhaust flue in the attic. The flashing is no longer functioning as intended. The roof sheathing was dry during the inspection. Repair the flashing around the exhaust flue.

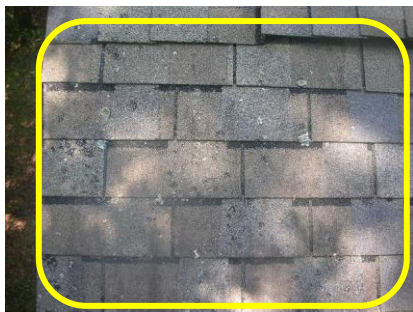
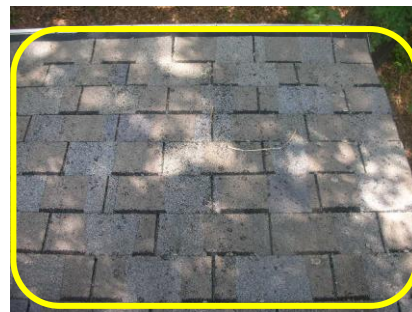
Repair Item: The roof shingles on the screen porch were damaged on the left rear corner. There were numerous locations where dime sized areas of granules were missing from the shingles. The granules protect the fiberglass and composition matt of the shingle. When the granules are removed, the matt is exposed to sun and weather which deteriorate and cause the shingle to fail. Replace the damaged shingles on the screen porch roof.

Black dots are dime sized areas of missing granules on porch roof

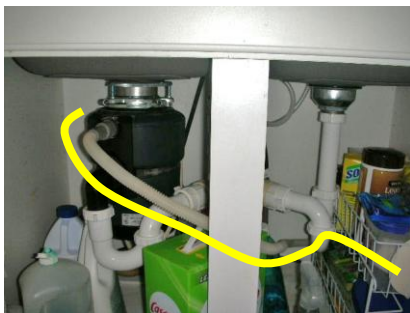
Repair Item: Commonly accepted plumbing practices require drain lines from a dishwasher to rise above the level of the sink drain before dropping down and connecting to the garbage disposal or waste line. This high loop prevents dirty water from the kitchen sink or garbage disposal accidentally flowing back into the dishwasher. The drain line for the dishwasher enters the cabinet at the bottom and rises to the garbage disposal. The current configuration does not provide the necessary high loop. Repair or replace by a licensed plumbing contractor.

Dishwasher drain missing high loop

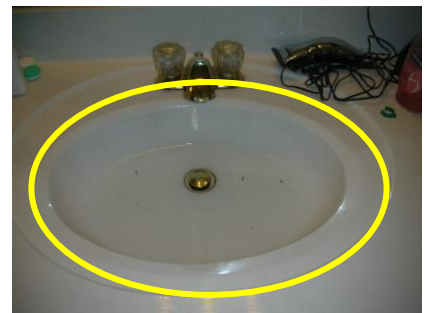
Slow draining master bath sink

Repair Item: The left sink in the master bathroom is a slow drain. Likely it is just clogged with toothpaste and hair. Initially apply over the counter drain cleaning products to treat the problem. If problem persists, repair by a licensed plumbing contractor.

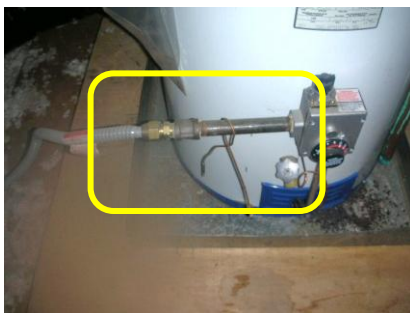
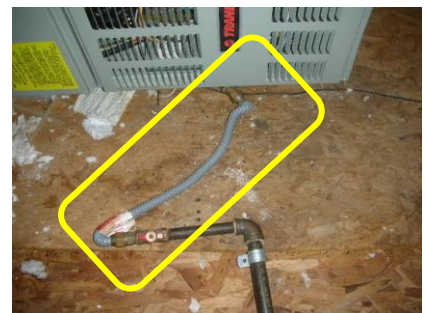
Repair Item: Commonly accepted building practices require sediment traps at all gas appliances. There is no sediment trap installed in the gas line supplying the gas water heater or attic furnace. Sediment traps are 3 inch pipe sections connected via a T pipe fitting after the appliance shutoff valve but before the gas appliance to allow sediment and moisture to fall out of the gas line to prevent clogs or damage to the gas controller of the appliance. Repair or replace by a licensed plumbing contractor.

Missing sediment leg at water heater

Missing sediment leg at attic furnace

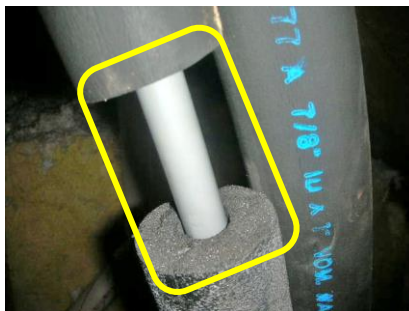
Polybutylene plumbing at water heater

Further Investigate: Polybutylene plumbing supply lines are installed in this house at the water heater. Polybutylene was used as water distribution piping in many homes built from the mid 1980's until the mid 1990's. The piping and associated fittings have had a failure rate and subsequent leakage sufficient to have been the subject of several nationwide class action lawsuits. Copper and brass fittings used in later years seem to have reduced the failure rate, but the piping may still fail due to problems with poor installation, improper handling, or chemical reaction with the water supply. For further details about the piping and your rights under the class action lawsuit settlements contact 1-800-392-7591 or visit the Website <http://www.pbpipe.com>. You may wish to have the plumbing system further evaluated by a licensed plumbing contractor.

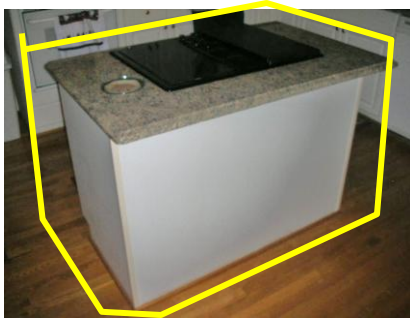
Safety Item: There is no receptacle in the center kitchen island. Commonly accepted electrical practices require one GFCI protected receptacle in kitchen islands. Without a receptacle on the island, people often place appliances on the island and drape the power cord across the walkway to the a nearby receptacle creating a trip hazard as well as the possibility of pulling the appliance off the island counter and crashing to the floor. Repair or replace by a licensed electrical contractor.

Kitchen island has no receptacle

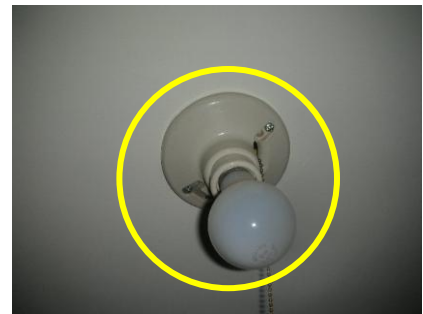
Closet light not enclosed

Repair Item: Commonly accepted electrical practices require surface mounted incandescent light fixtures in clothes closets have fully enclosed bulbs and be at least 12 inches from storage. The light fixtures in the clothes closets have exposed bulbs. Exposed bulbs can cause stored items to catch fire. Repair or replace by a licensed electrical contractor.

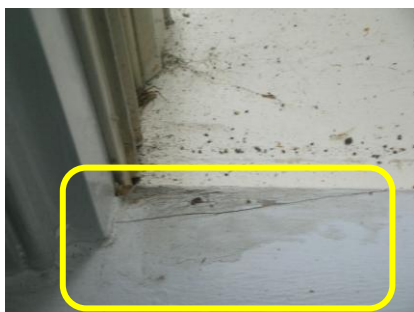
Further Investigate: There is water staining and discolored wood at the bottom left corner of the living room window sill. Moisture meter readings indicated a slightly higher than normal moisture content. Further investigate to determine the source of the water intrusion as well as design and implement a repair procedure.

Water stained window sill living room

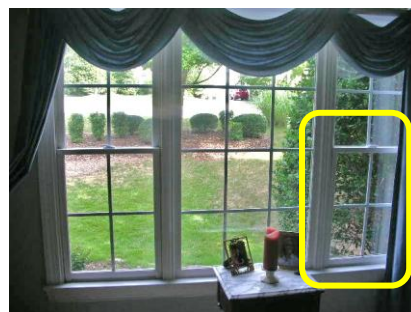
Lower sash not square in frame

Further Investigate: The right lower sash of the living room window did not fit squarely in the frame. As the sash was moved up and down, a gap would appear between the sash and frame at different locations. The sash operated but does not make a complete seal and is not square to the frame. Further investigate to determine if the frame, track or sash is out of square and repair or replace.

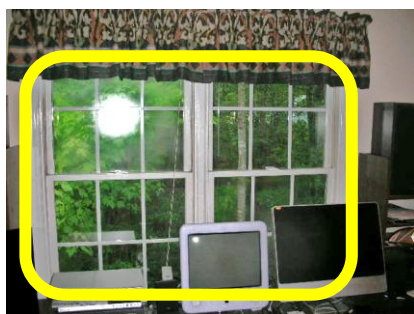
Repair Item: The windows in the second story music room that overlook the backyard have two failed seals. The lower sash of one window and the upper sash of the other window have failed seals. The windows are not functioning as intended. Replace the failed windows.

Double pane seals failed

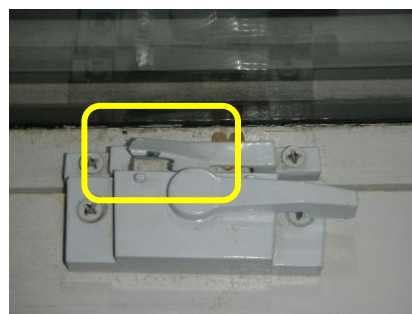
Broken window sash lock front bedroom

Repair Item: The window sash lock of the front window of the bedroom to the right of the top of the stairs is damaged. The sash lock has been torn and is damaged. Replace damaged window sash lock.

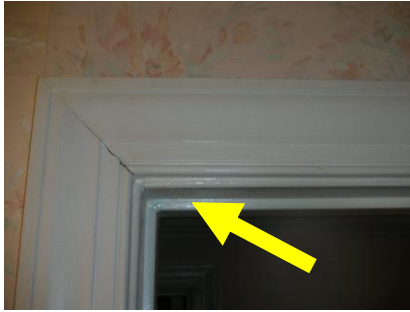
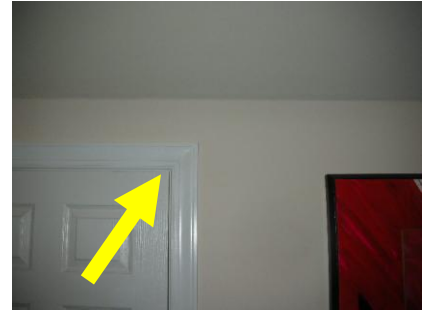
Repair Item: There are several doors throughout the house that bind at the door knob side top. Included are the second story hall bathroom door and the closet door in the music room. Repair or replace.

Hall bathroom door binds

Music room closet door binds

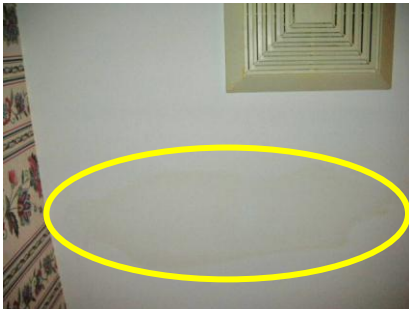
Further Investigate: There is a water stain in the ceiling of the first story bathroom near the exhaust fan. The exhaust hood on the roof has been recently repaired and may have corrected the problem. Subsequently observe the ceiling for darkening or additional rings of water stains indicating the leak is continuing.

Water stain 1st floor bath ceiling

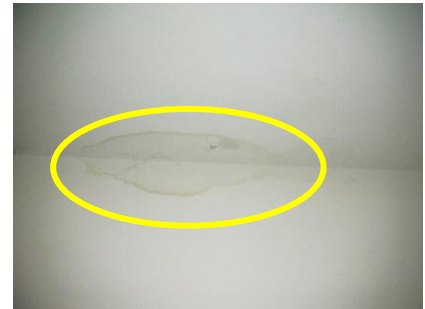
Water stain master closet ceiling

Further Investigate: There is a water stain in the master closet ceiling. The water stain is directly under the plumbing vent stack where it penetrates the roof. The insulation was stained and matted at this location. There was no water staining of the roof sheathing or on the plumbing vent stack. Further investigate to determine the source of the water intrusion as well as design and implement a repair.

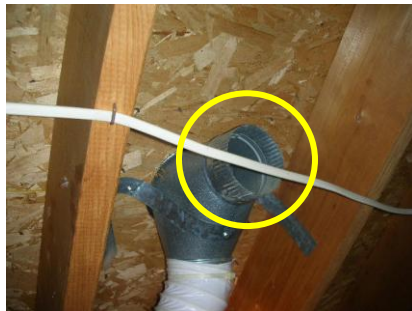
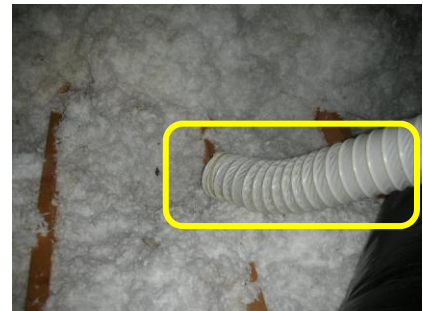
Repair Item: The duct for the second story hall bath exhaust fan does not terminate at the exterior. The hall bath duct has fallen and it exhausting directly into the attic. The ducts should terminate outside the attic. Repair or replace by a licensed mechanical or general contractor.

Metal Y missing hall bath duct

Hall bath exhaust fan duct into attic insulation

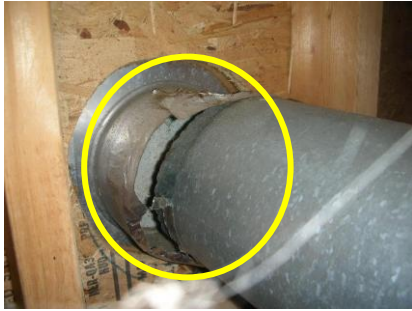
Repair Item: The duct for the kitchen down draft exhaust fan is disconnected where it passes through the foundation wall to the exterior. The exhaust is being deposited in the crawlspace rather than exterior. This will coat the crawlspace with grease and increase the moisture level. The duct is not functioning as intended. Repair the duct.

Down draft kitchen exhaust duct disconnected

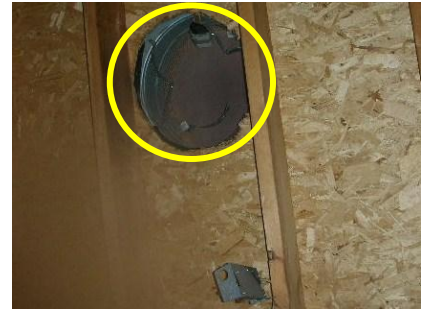
Attic fan removed

Further Investigate: The thermostatically controlled attic ventilation fan has been removed from the housing. The housing and exterior cover has become a passive ventilation system. The fan is not functioning as intended by the manufacturer but does not leak at this time. When house is re-roofed, remove the remainder of the fan and repair hole in sheathing.
